Application of Electron Microscopy Techniques to the Investigation of Space Shuttle Columbia Accident

SEMS 2005

Dr. Sandeep Shah

Lead, Materials Diagnostics Team, NASA MSFC

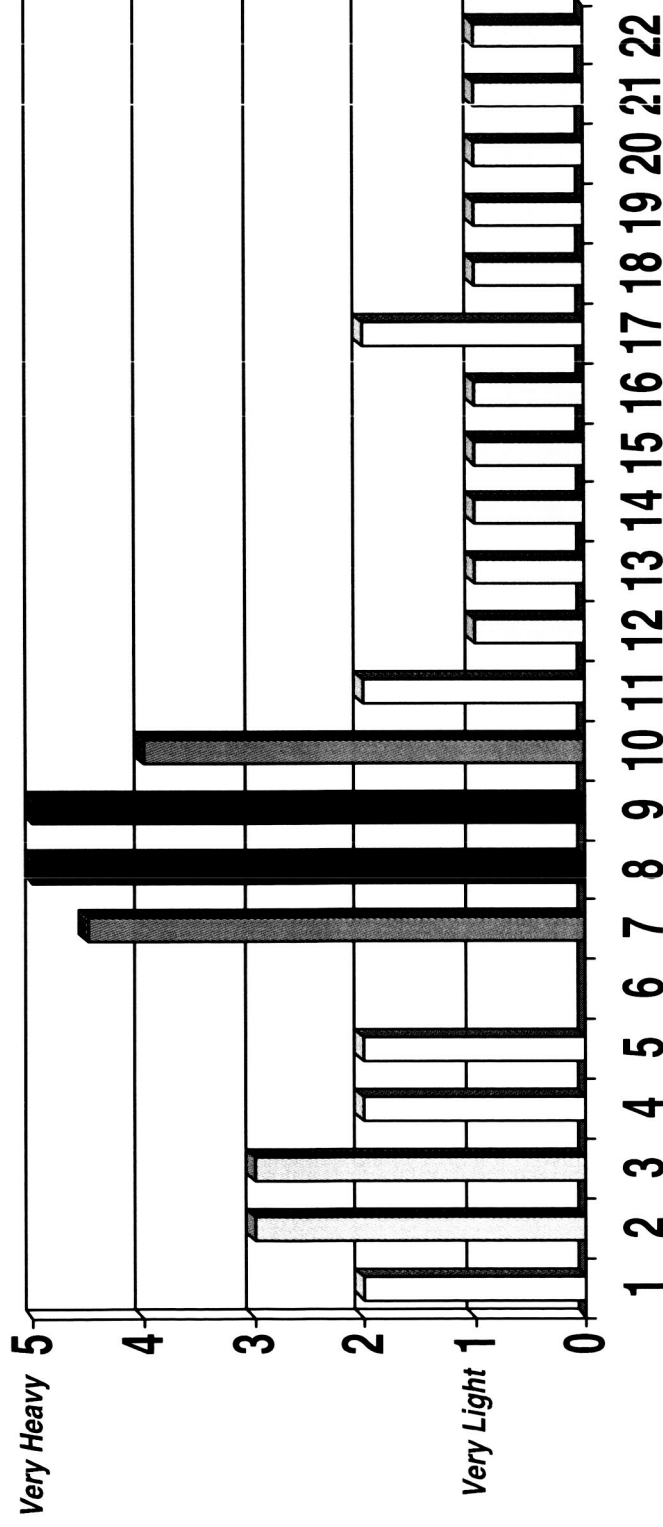
Qualitative Slag Deposition Assessment “Very Light” to “Very Heavy”

Distribution of “slag” deposition volume
was centered around panels 8 & 9 on Left Wing Leading
Edge RCC.

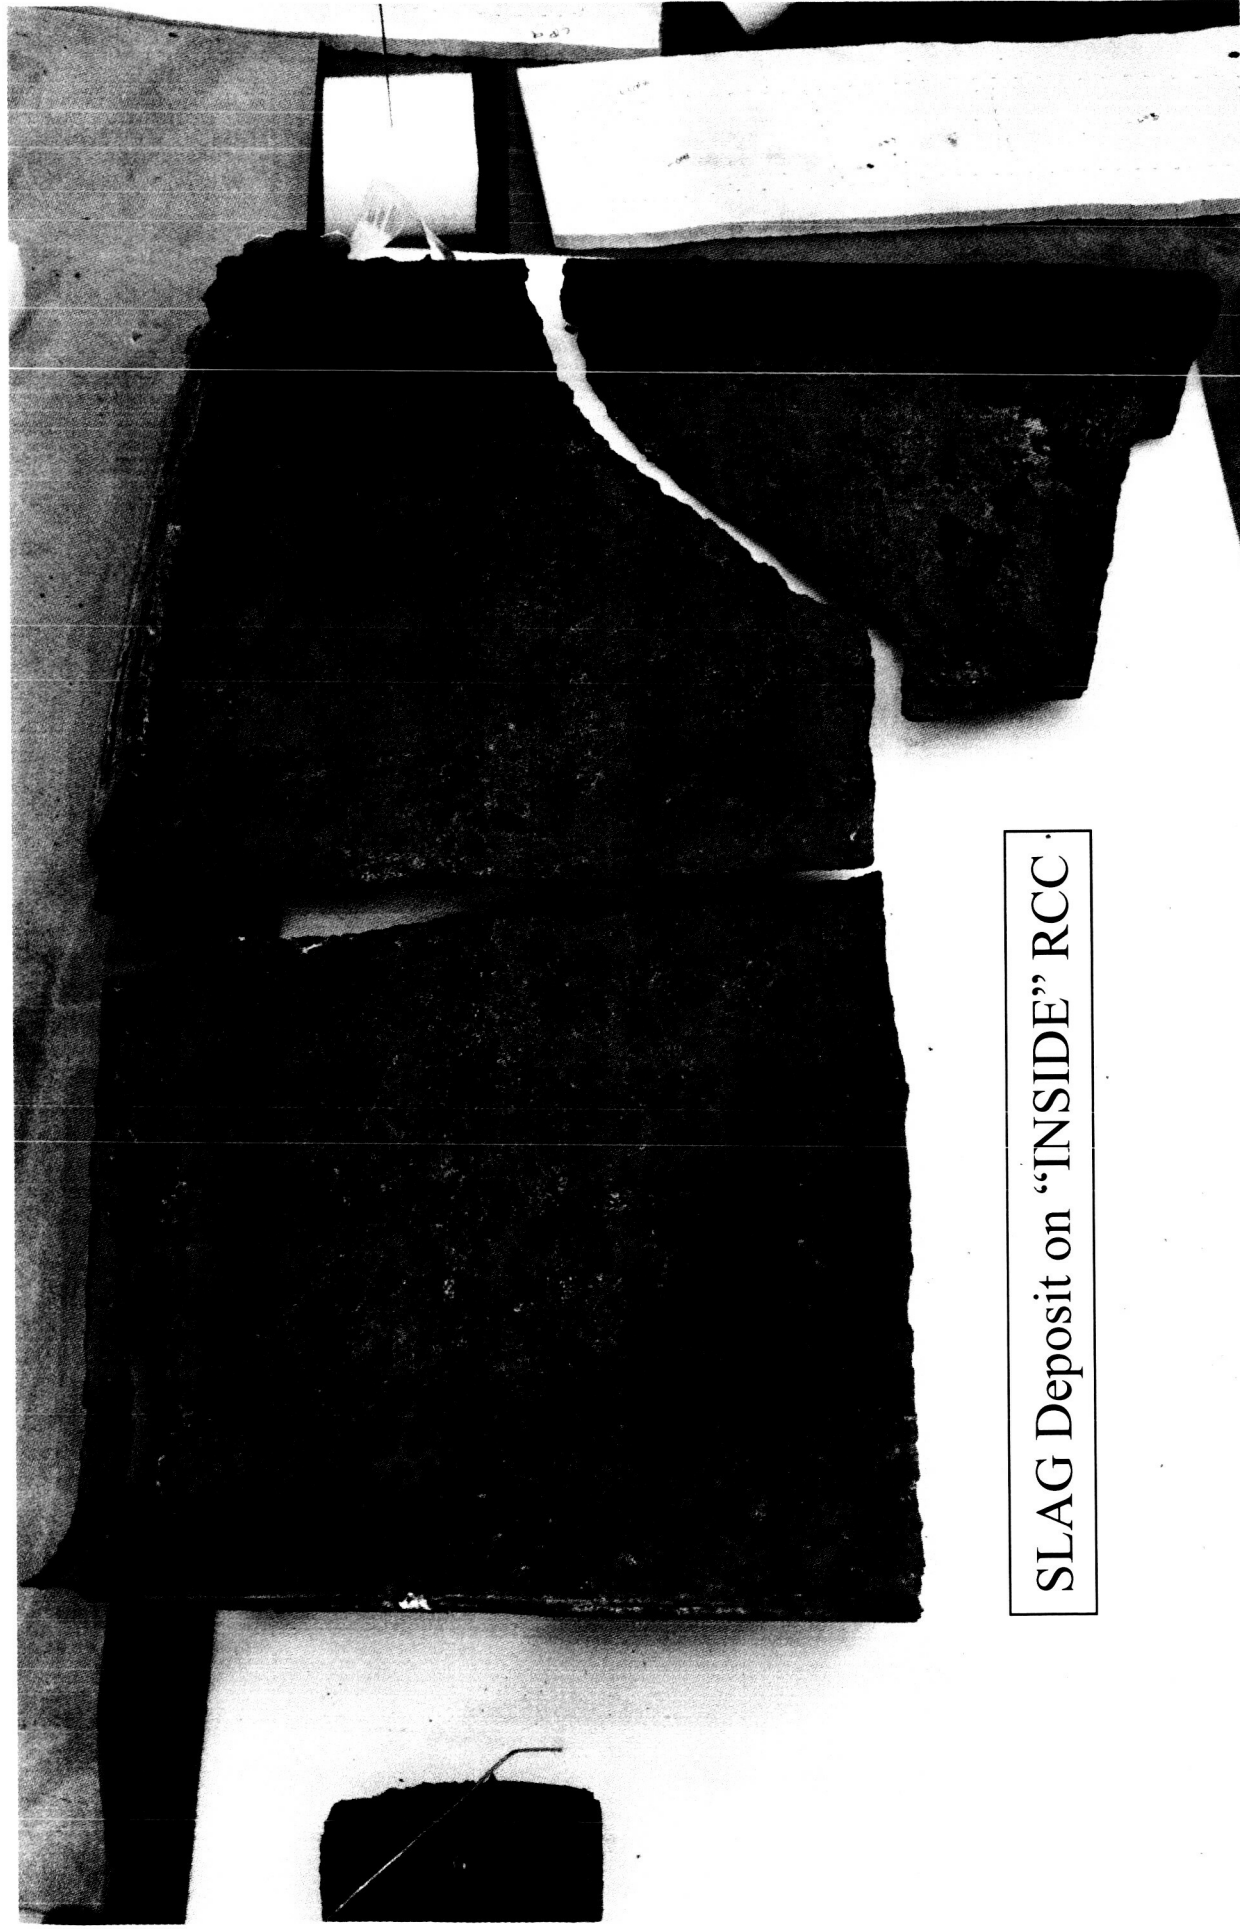
Example Debris, LH RCC 8

SLAG Deposit on "INSIDE" RCC

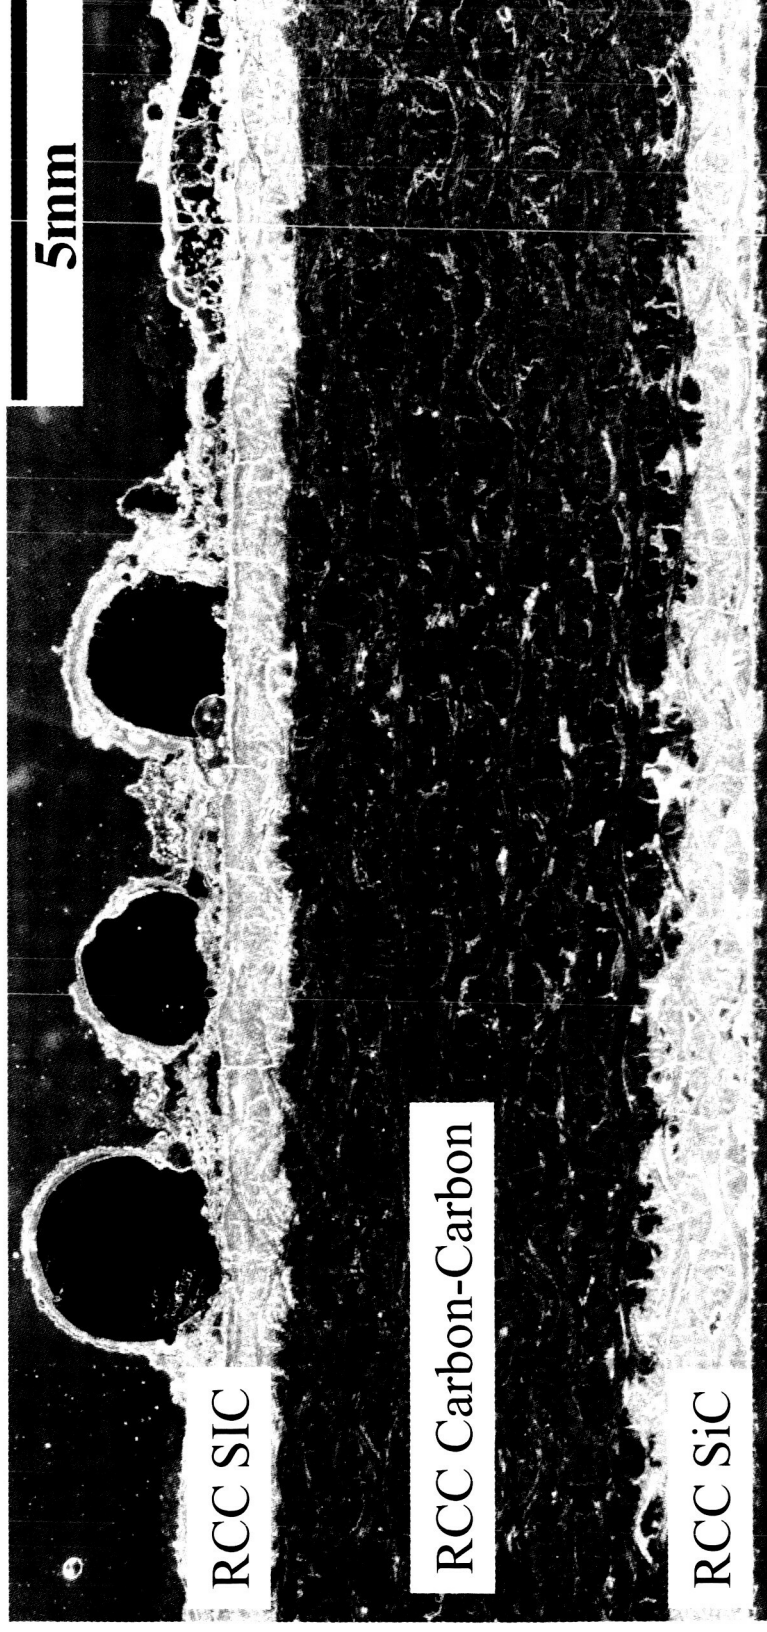
Sample 3 X-section

Successful in cutting through the feature of interest guided by radiography ²³

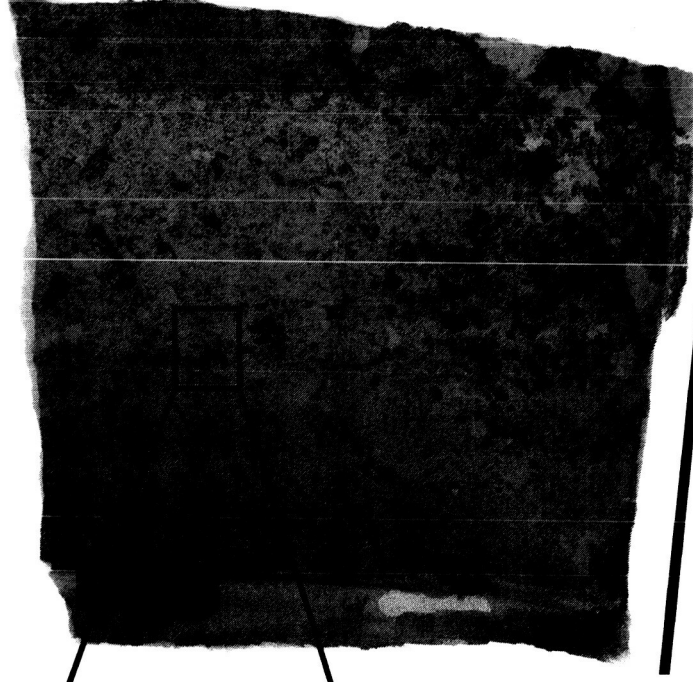
Slag Item 2200, Sample 6C1

Left Wing RCC #8 - Slag Feature

Spheroids

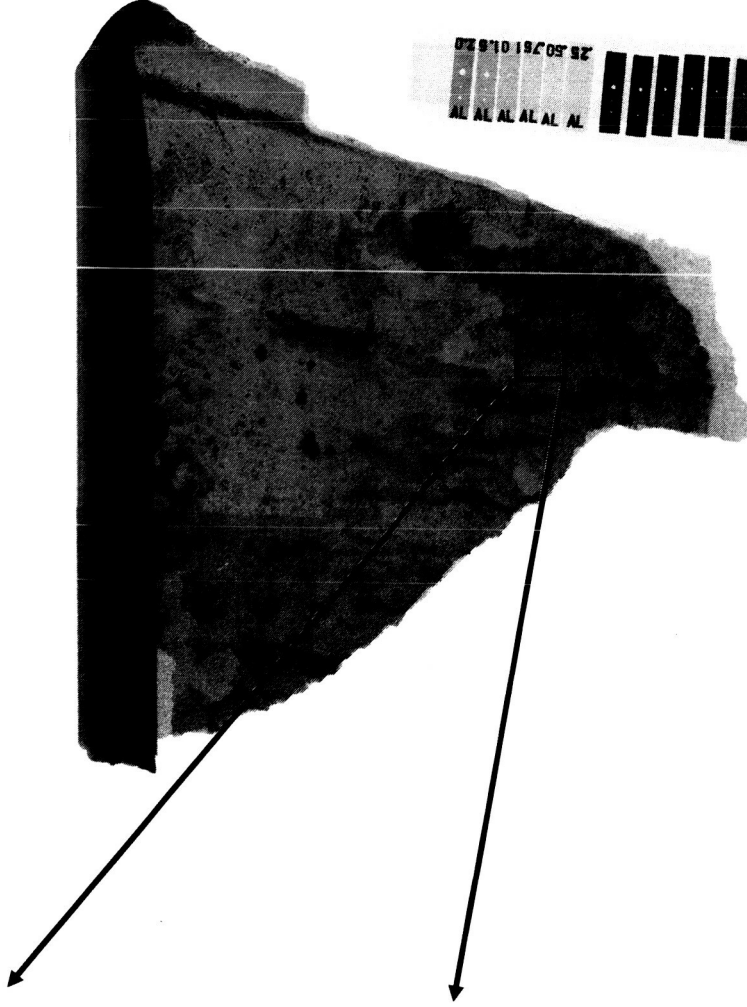
Slag Item 43709, Sample 2A1

Left Wing RCC #8 - Slag Feature Thick Tear Shaped

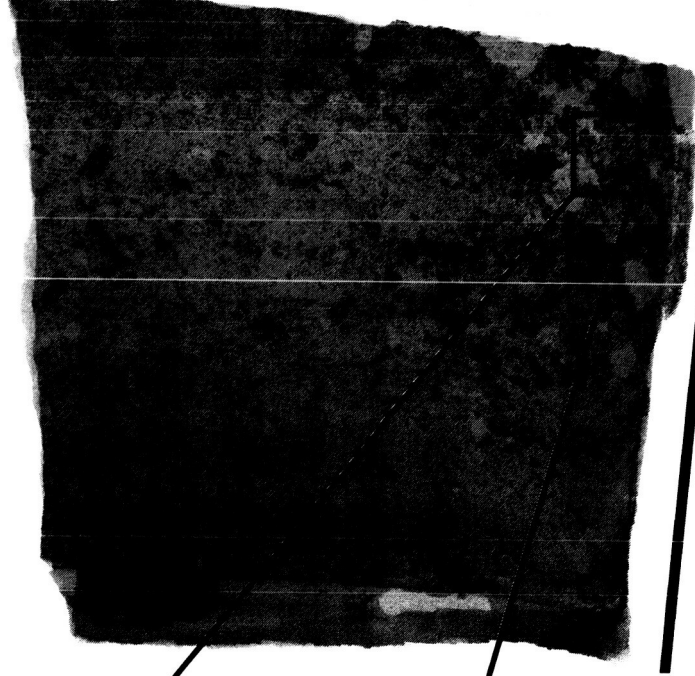
Slag Item 2200, Sample 6A1

Left Wing RCC #8 - Slag Feature Thick Globules

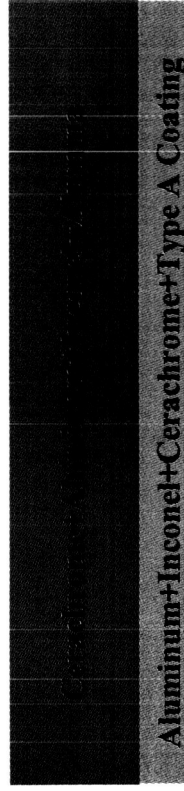
Slag Item 16523, Sample 4A1

Right Wing RCC #8 - Slag Feature

Uniform Deposit

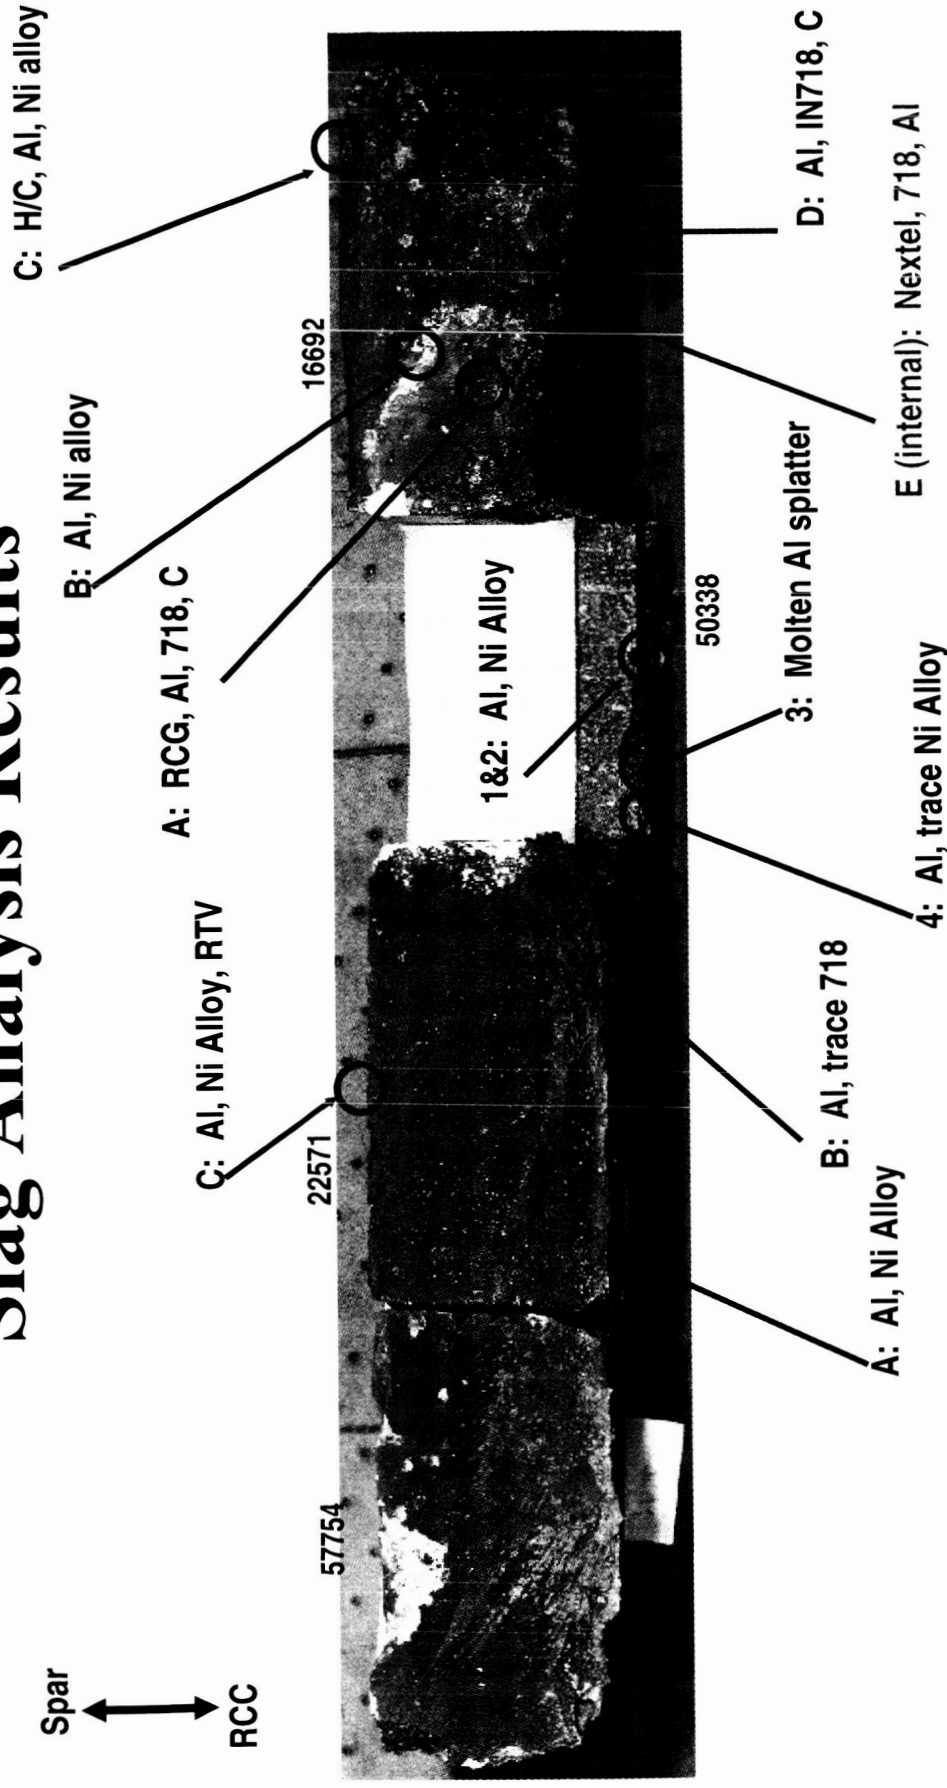
Reconstructed View LH Carrier Panel 9 Tiles, Lower Slag Analysis Results

These findings suggest flow of material from inside the RCC out through the upper and lower CP locations.

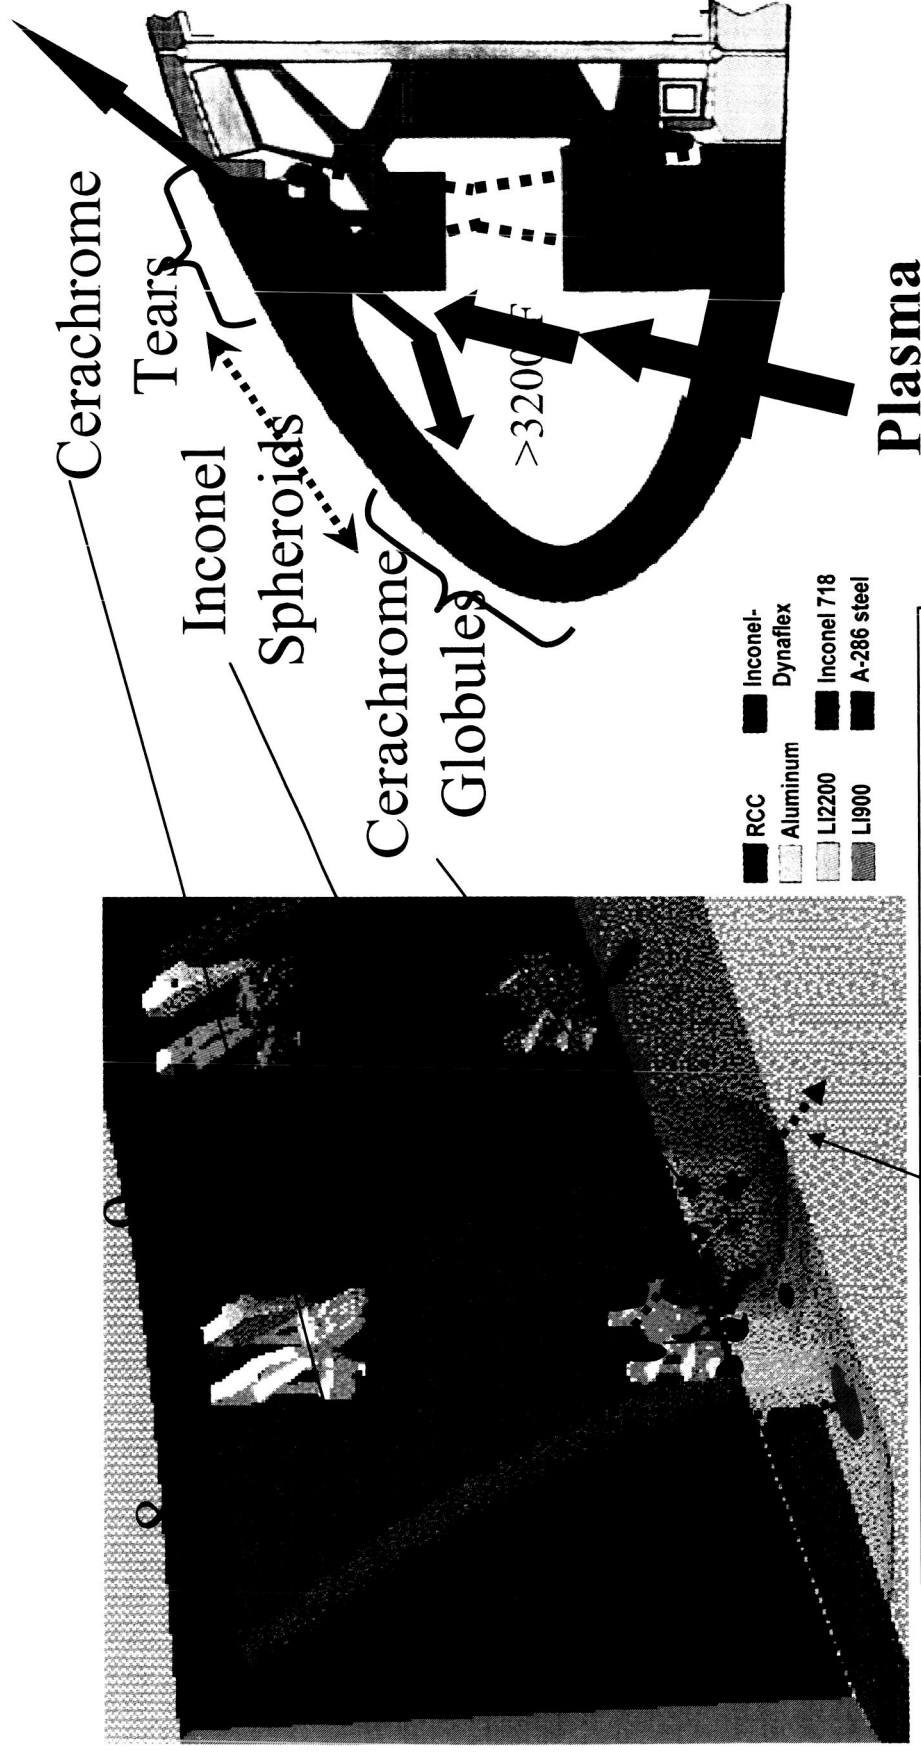
Proposed Breach Location & Plasma Flow Based On Slag Results

- Cerachrome + Inconel in first deposited layers
 - Melting of spanner/foil/fittings + Insulator
- Aluminum deposition secondary event

- No indication of stainless steel spar fittings (A286) in slag
 - Breach location away from spar fittings
- Large amounts of melted ceramic cerachrome insulator
 - High temperature >3200°F
